AMMRC TR 85-28

ENVIRONMENTAL ASSISTED CRACKING IN HIGH HARDNESS ARMOR STEEL

WILLIAM A. HERMAN and GLENN M. CAMPBELL
PROCESS RESEARCH DIVISION

September 1985

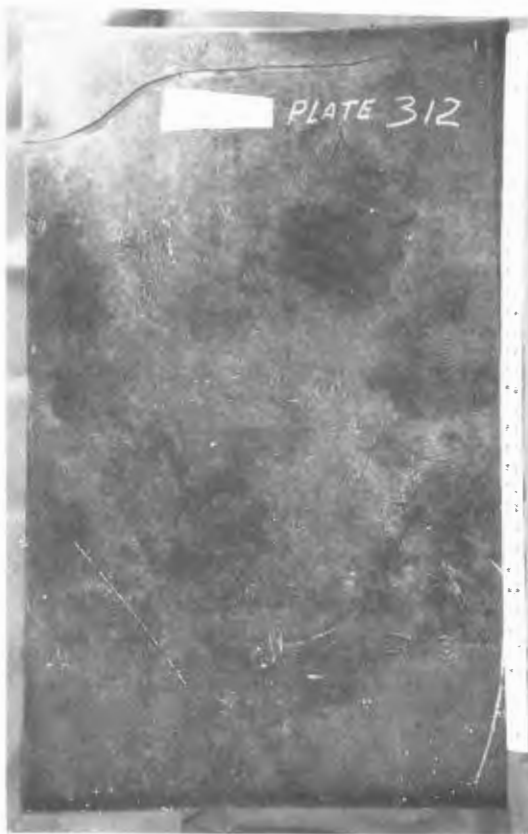
Figure 1. Catastrophic Cracks in Detail Parts.

Part 312

Part 312, Close-up of Cracked Area

At the request of several program managers, AMMRC investigated cracking of high hardness armor steel (MIL-A-46100). Cracks were first reported on detail parts that were stored after being cut from large plates. In addition, the cracking was reported during subsequent fabrication steps, as well as in fielded vehicles.

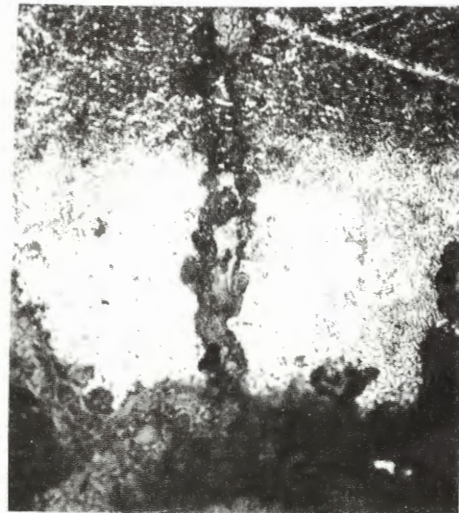
Figure 2. Comparison of Cut Edges

a. Mechanical Shearing

b. Water-Shielded Plasma

c. Gas-Shielded Plasma

Two of three cutting processes used caused edge cracks up to 0.09 inch in length.
These microcracks function as EAC initiation sites.

d. Magnetic Particle Inspection of Plate Edge in a.

These alternate methods, water-shielded plasma and cold shearing, were successful in reducing the HAZ size. However, they caused severe edge cracking on the as-cut detail parts (Figure 2). When water-shielded plasma was used, the rapid cooling of the cut edge produced a very narrow HAZ (30 mil), with a thin (5 to 10 mil) layer of untempered martensite at the cut edge. The formation of this martensite in conjunction with the high cooling rates resulted in the formation of quench cracks at 90° to the plate surface. Analogously, cold shearing of the plates introduced large amounts of mechanical deformation which over stressed the material and cracked the edge at a 45° angle (Figure 2).

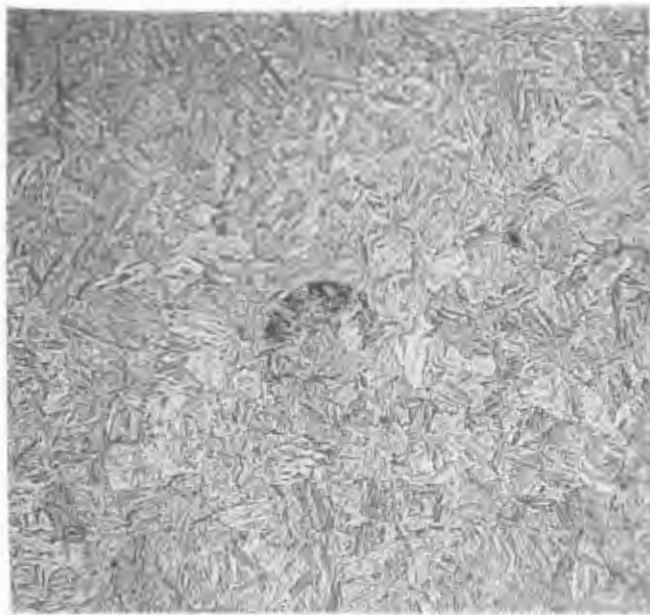
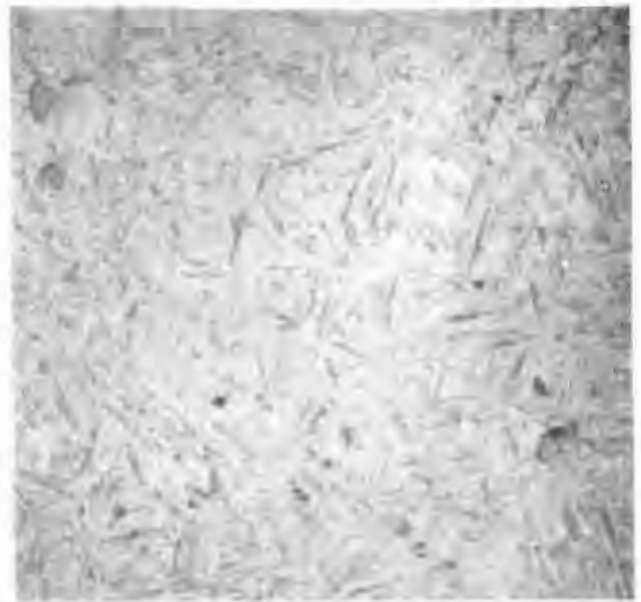
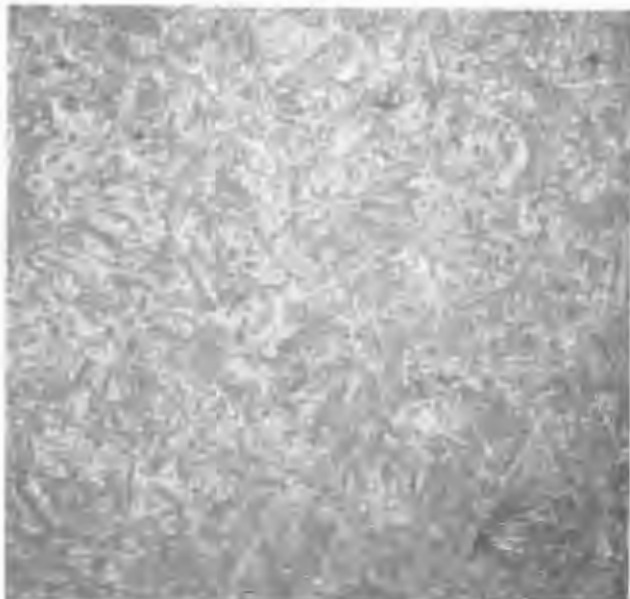
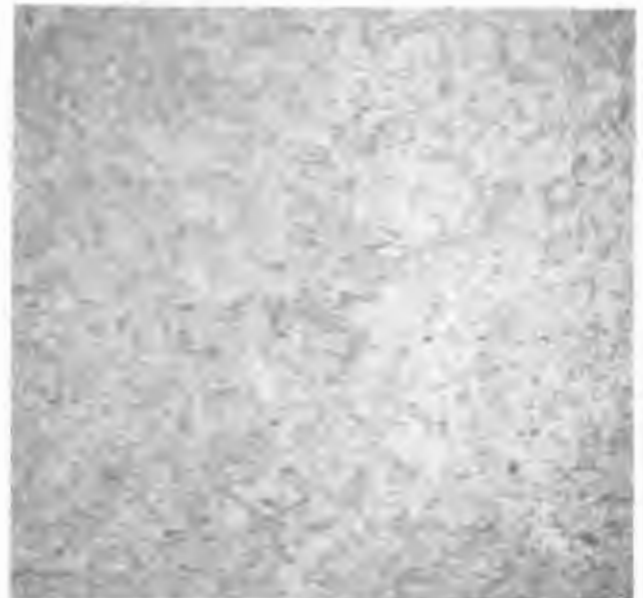
Figure 3. Comparison of Microstructures.

Cracked Plate, Mn-Mo-B

Uncracked Plate, Mn-Mo-B

Raw Stock, Ni-Cr

1. Tempered martensite microstructure seen in all samples.
2. Inclusions are spheroidized.
3. No inherent material deficiency (i.e., banding) can be linked to the cracking phenomenon.

For comparison, a nickel-chromium grade of high hardness armor was examined and similar results, both microstructurally and mechanically, to the Mn-Mo-B grade were obtained (Table 5 and Figure 3). Since the Ni-Cr grade of high hard is a richer alloy (Table 3), it is typically tempered at higher temperatures. This reduces the relative tendency for EAC to occur. However, it is felt that if Ni-Cr and Mn-Mo-B high-hard steels are processed in exactly the same manner, both will possess similar susceptibilities to EAC.

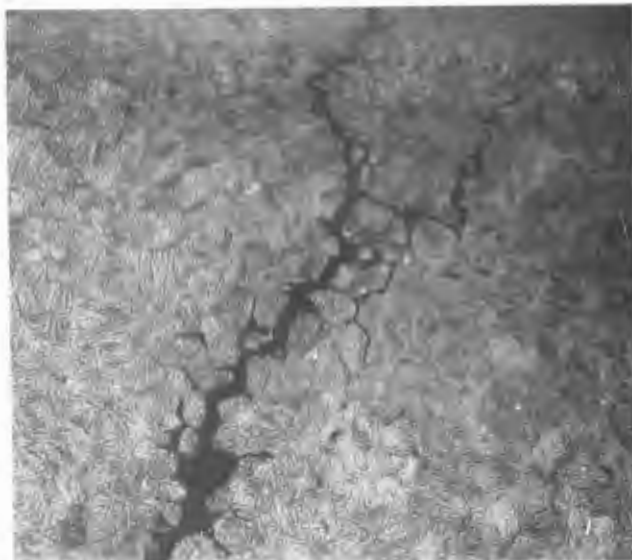
Figure 5. Fracture surfaces of service crack.

Optical Metallography of Crack Tip
from 0.030 inch Crack

SEM of Crack Tip
from 2 inch Crack

It appears therefore, that the susceptibility of high hardness armor to EAC is linked to a preexistent crack interacting with sufficient levels of stress to cause crack propagation in the ambient environment. Table 5 shows data for a series of different high strength materials tested under various environments and all the materials with similar strength levels show stress corrosion fracture toughnesses of 15 to 20 ksi $\sqrt{\text{in}}$. These data are consistent with Dawson and Levy,² who have suggested that the susceptibility of a material to EAC is not dependent on the type of environment, but rather on the material strength, with the susceptibility increasing with the yield strength.
